PERATION

GREENHOUSE

SCIENTIFIC DIRECTOR'S REPORT

ANNEX 3.2 U. S. NAVY STRUCTURES

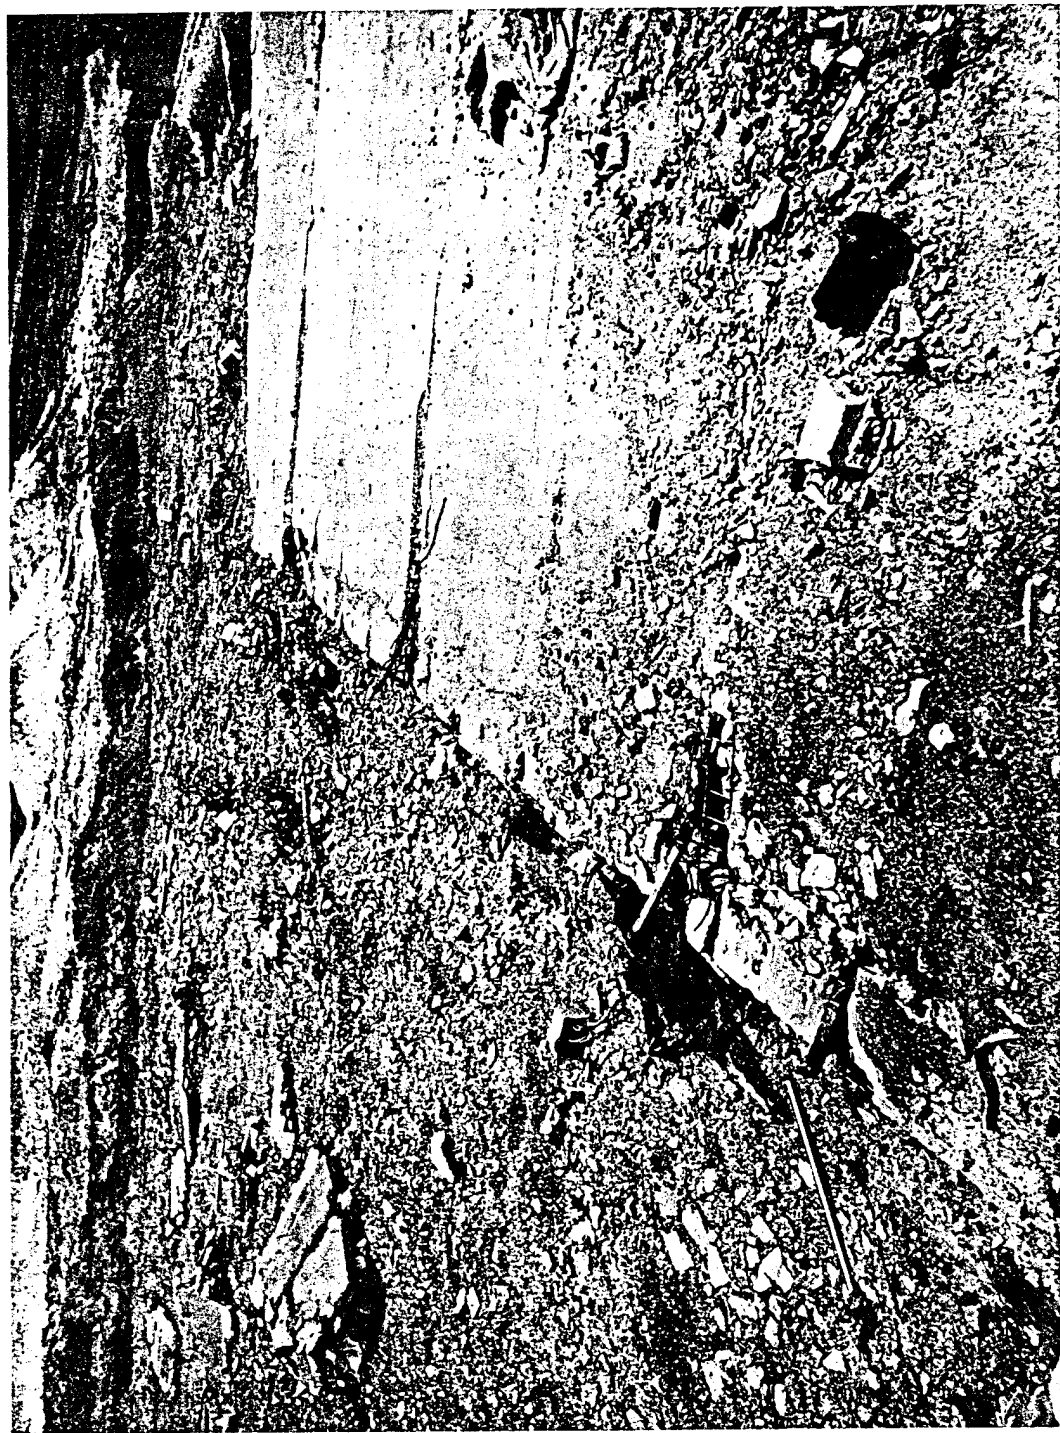
Fig. L.189 Close-up View of Rear Wall, Taken from Left End, Structure 3.2.3a

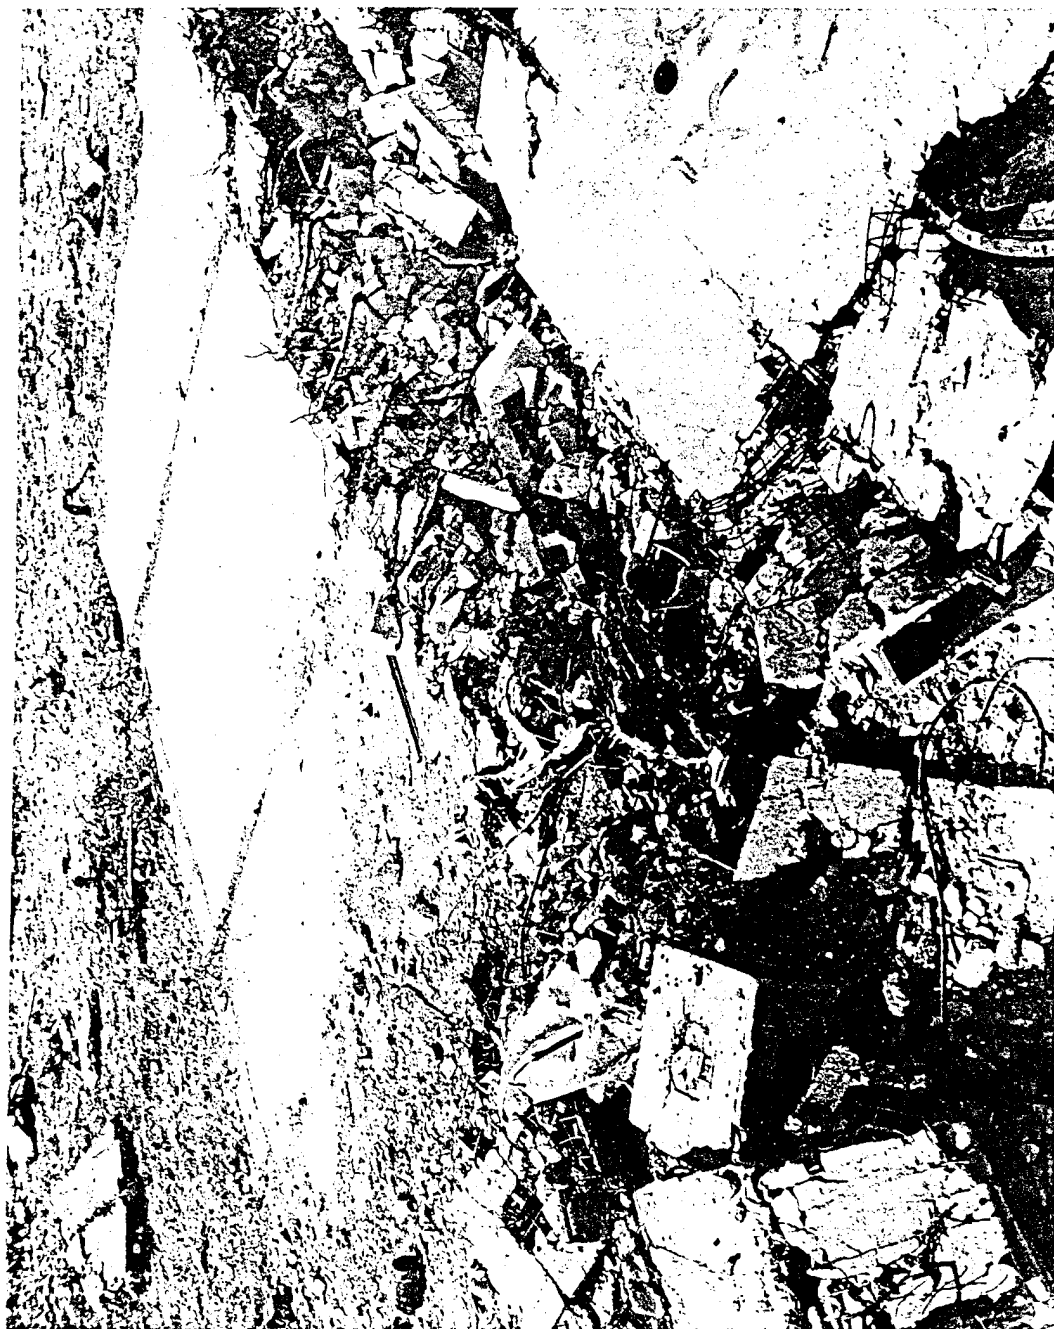
Fig. L.191 Base of Rear Wall with Trusses Still Attached to Foundation; Lower Row of Cells Collapsed; Structure 3.2.3a

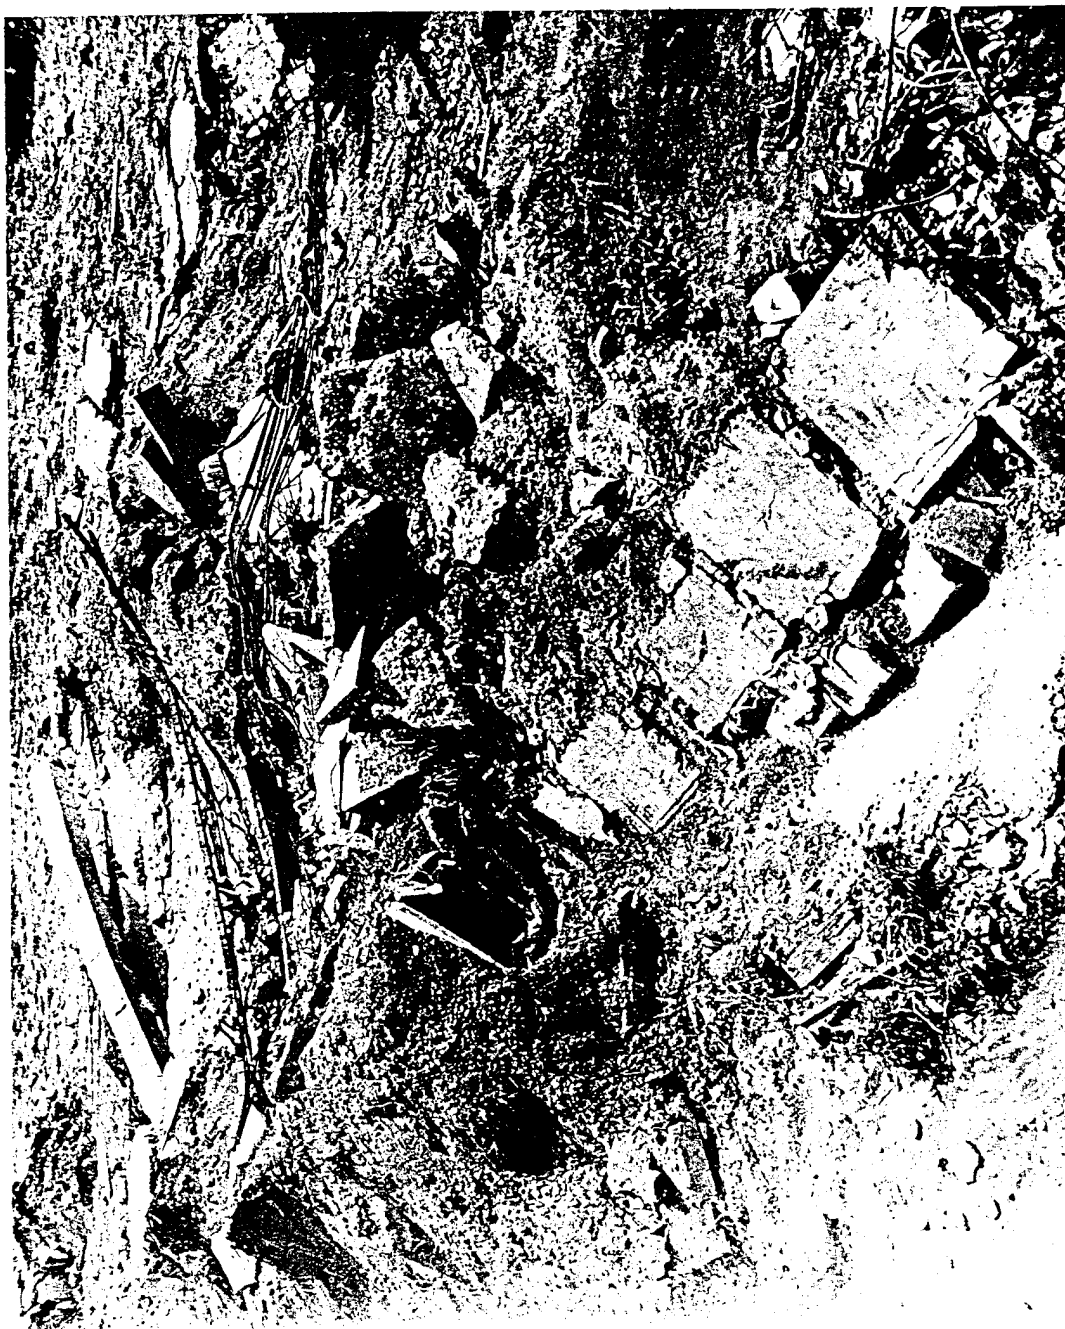
Fig. L.192 Close-up View of Lower Row of Cells at Foundation Line of Rear Wall, Structure 3.2.3a. Earth dumped over cells obscures rest of panel, but it is generally undamaged.

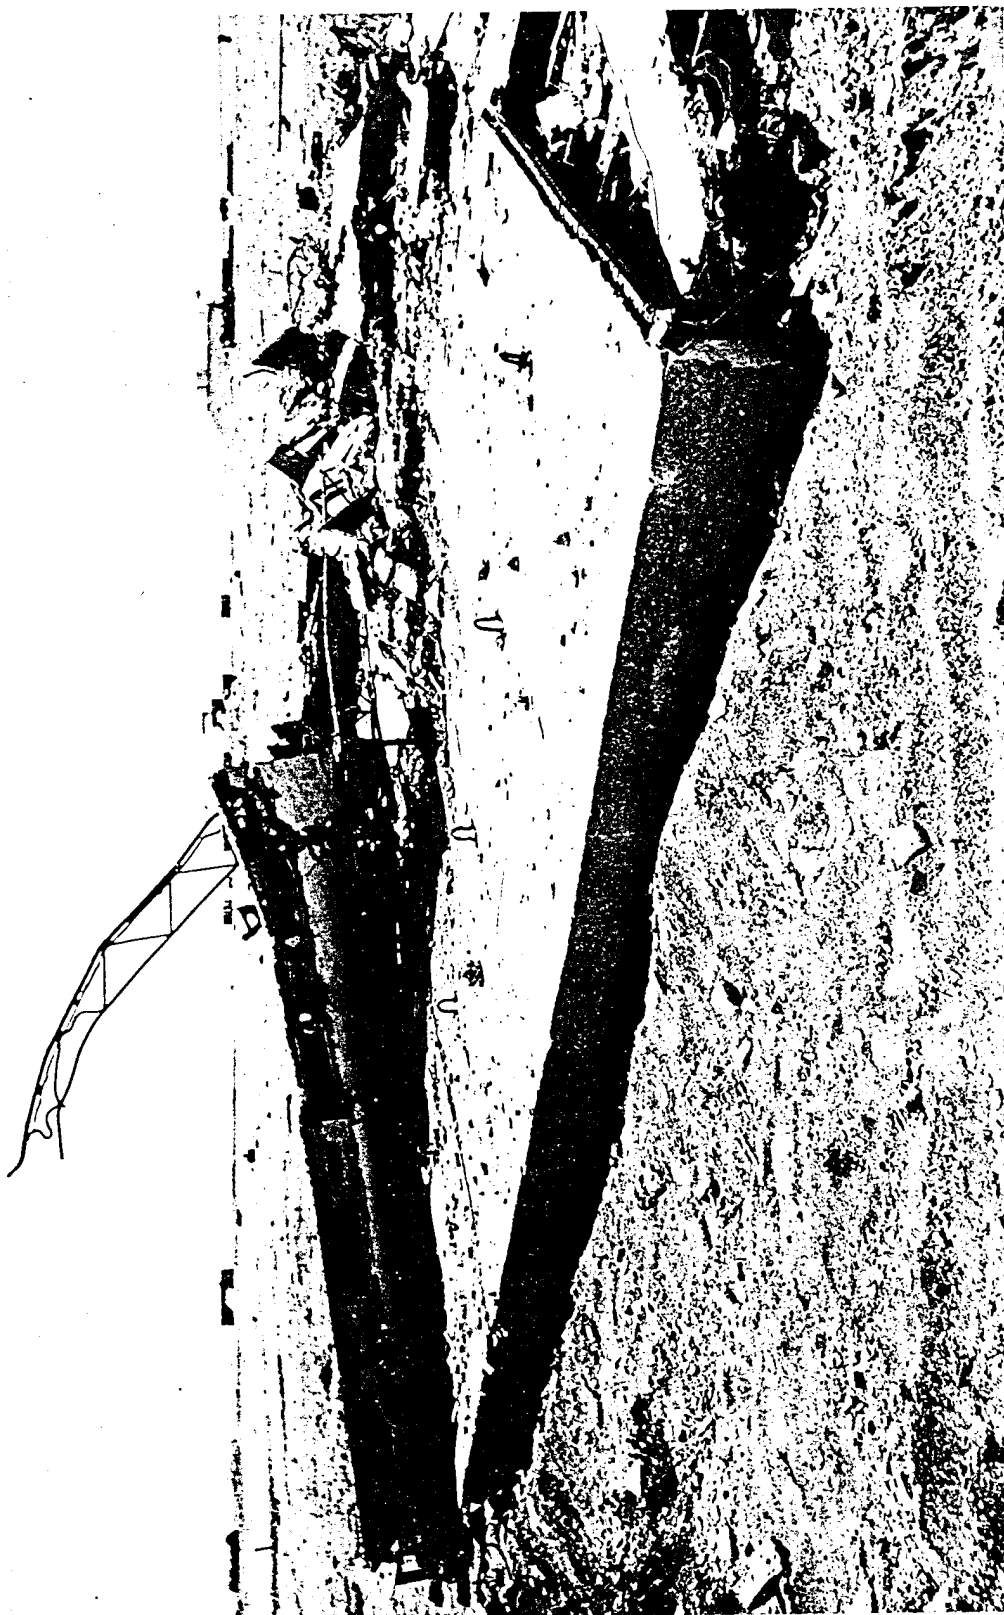
Fig. L.195 Left Half of Roof, Located about 100 ft behind Foundation, Structure 3.2.3a. Front edge of roof, in foreground, practically undamaged.

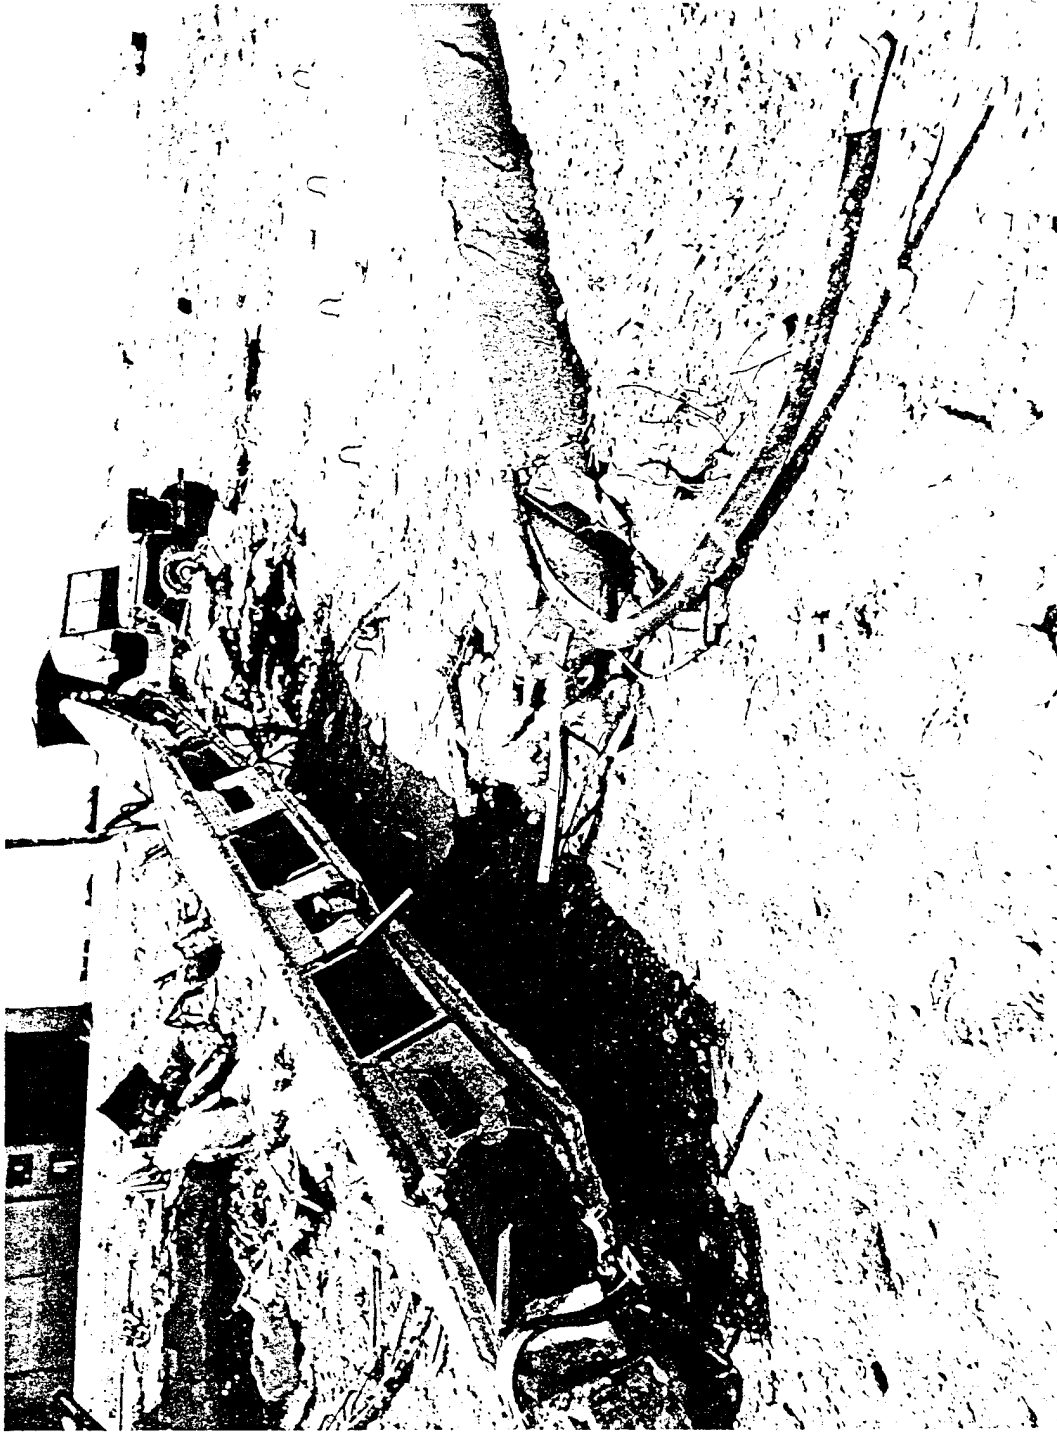
Fig. L.196 Part of Roof Panel from Left Edge Torn Loose from Rest of Roof Section, Structure 3.2.3a. This panel is the one that has one row of cells still attached to left end wall.

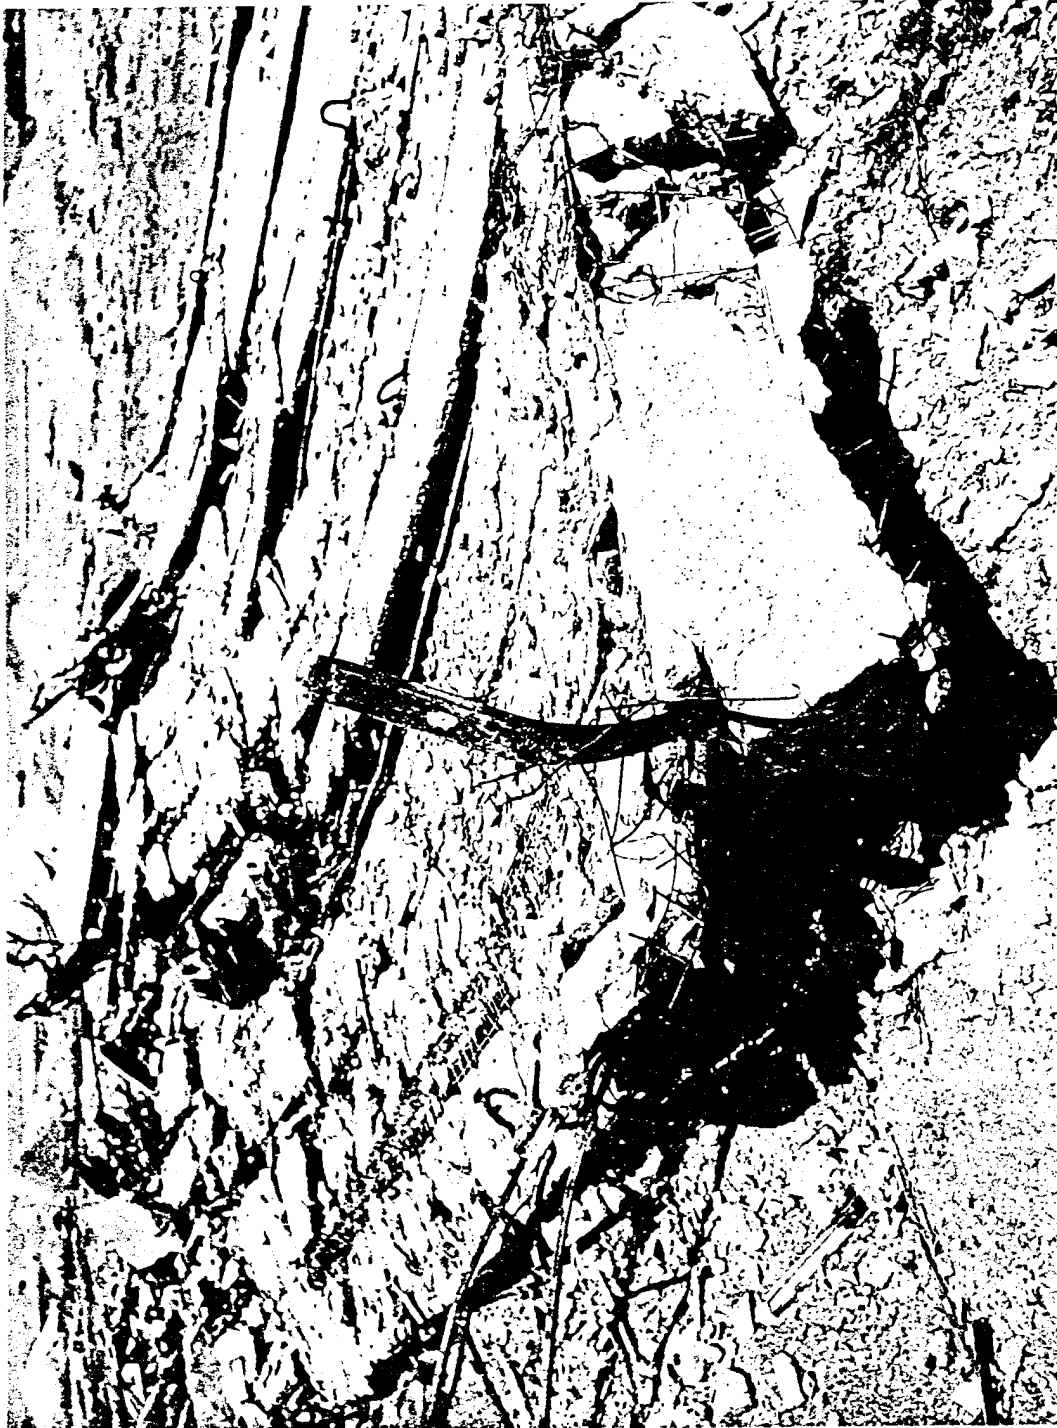
Fig. L.200 Detail View of Right Half of Roof, Structure 3.2.3a. The edge along the left side of photograph is the centerline of the original roof. Note how splice of edge truss ruptured through weld.

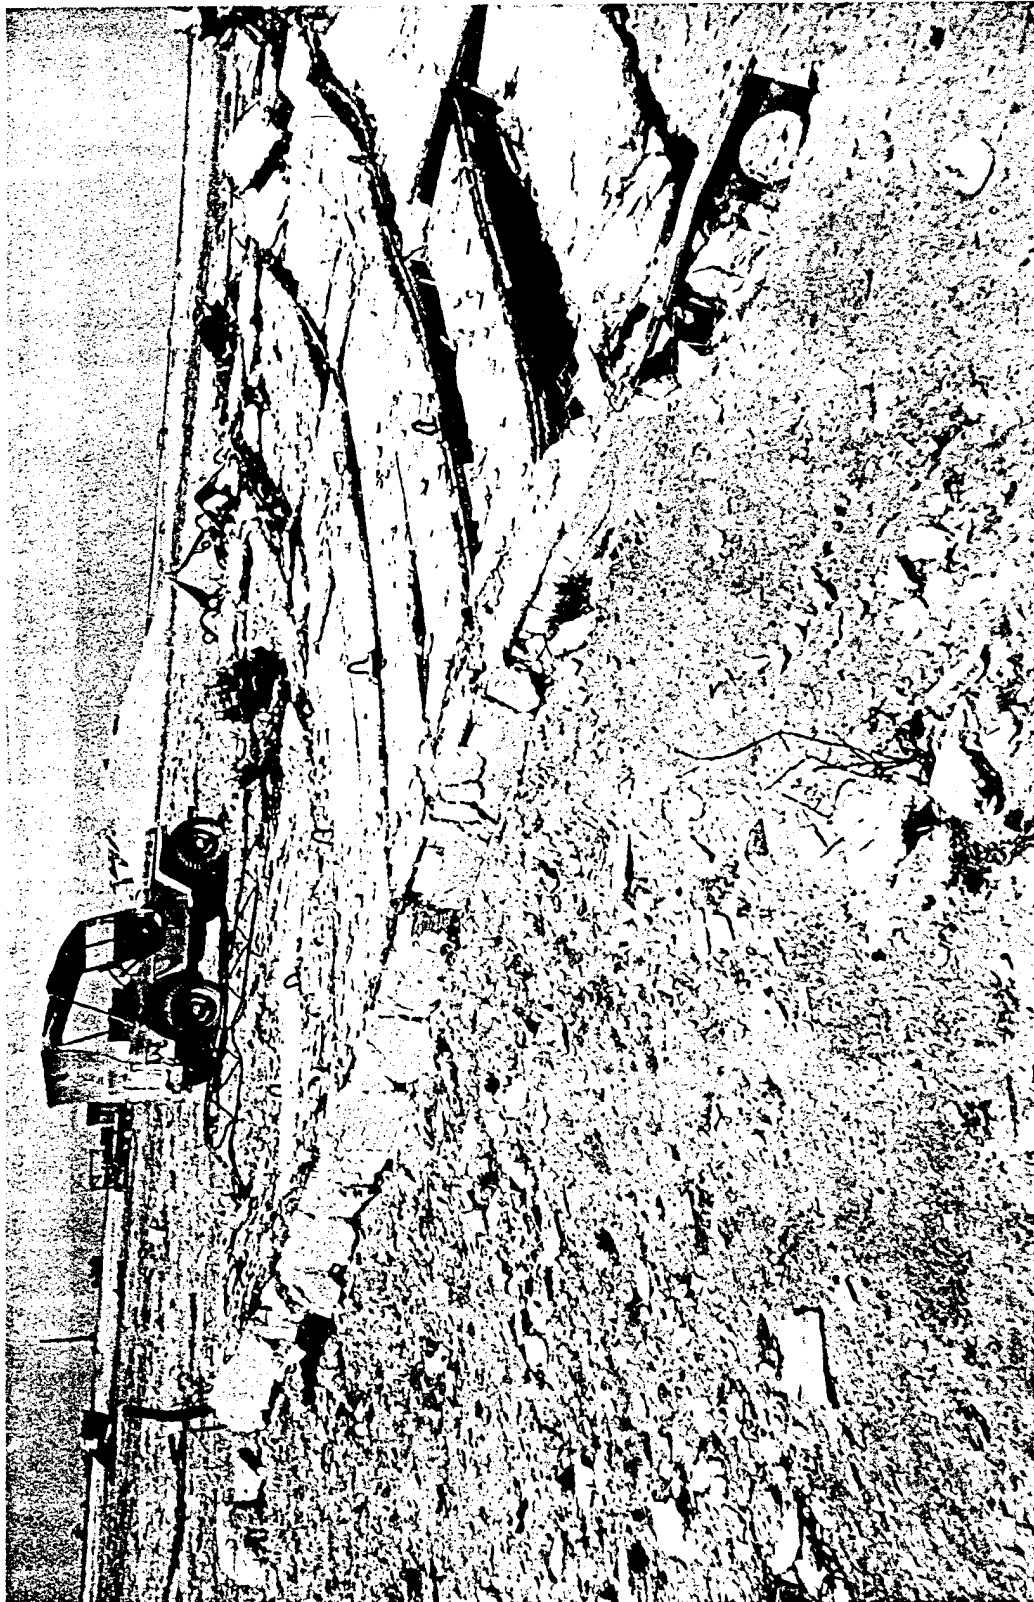
Fig. L.201 Detail View of Right End of Roof Edge Truss, Structure 3.2.3a

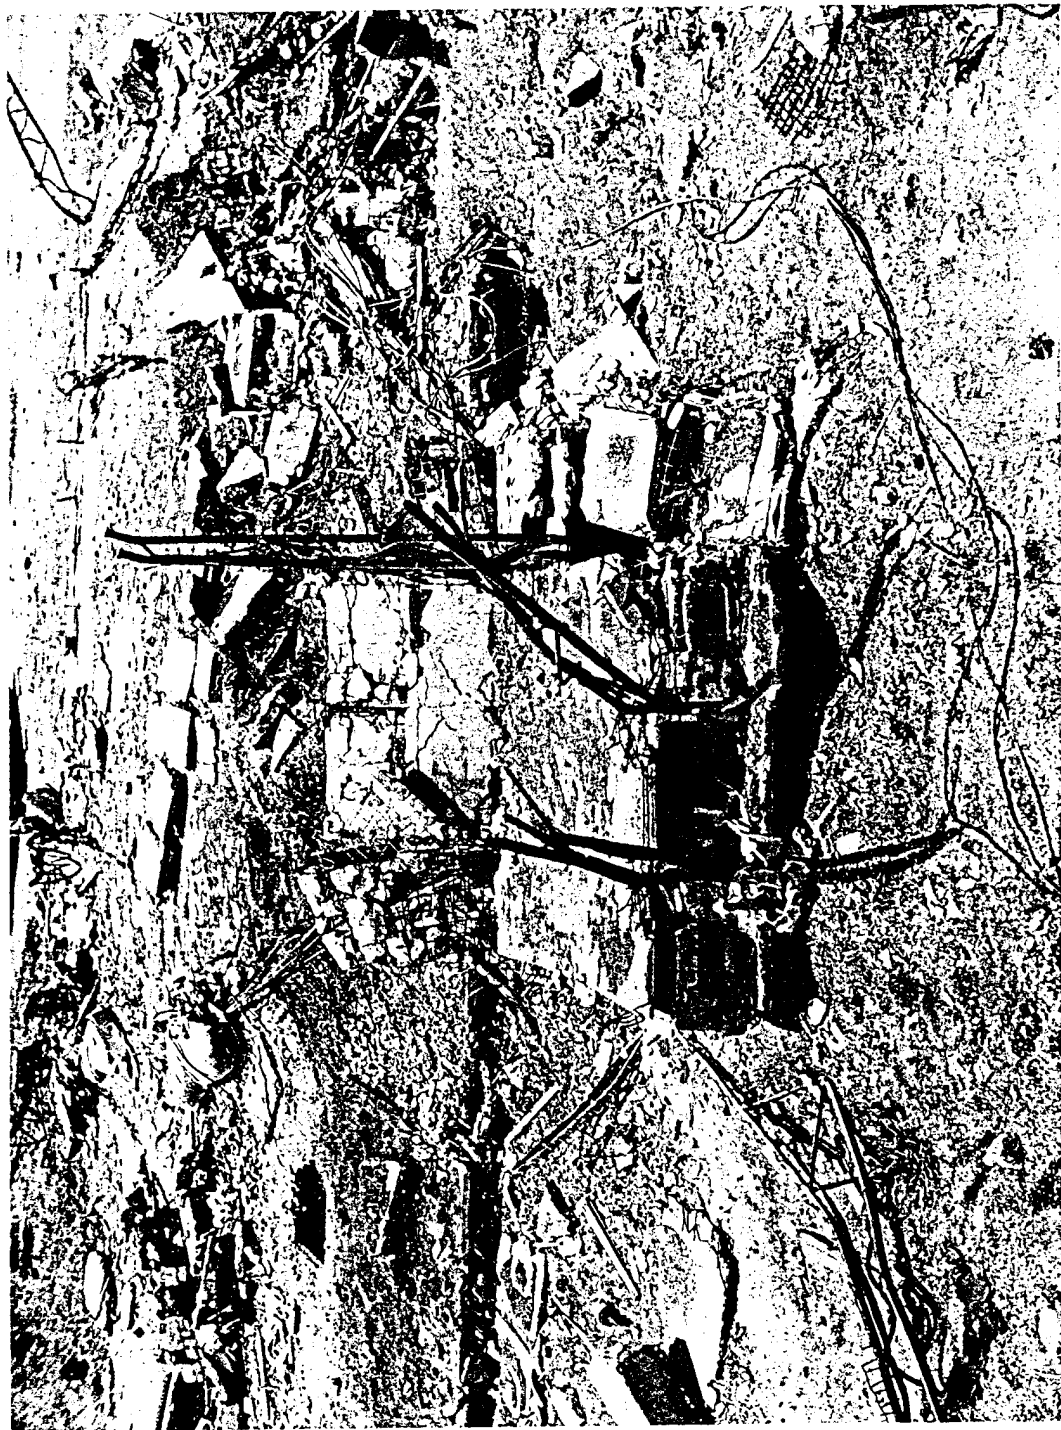
Fig. L.203 Remains of Front-wall Panel No. 25 after Being Hurled about 35 ft, Structure 3.2.3a

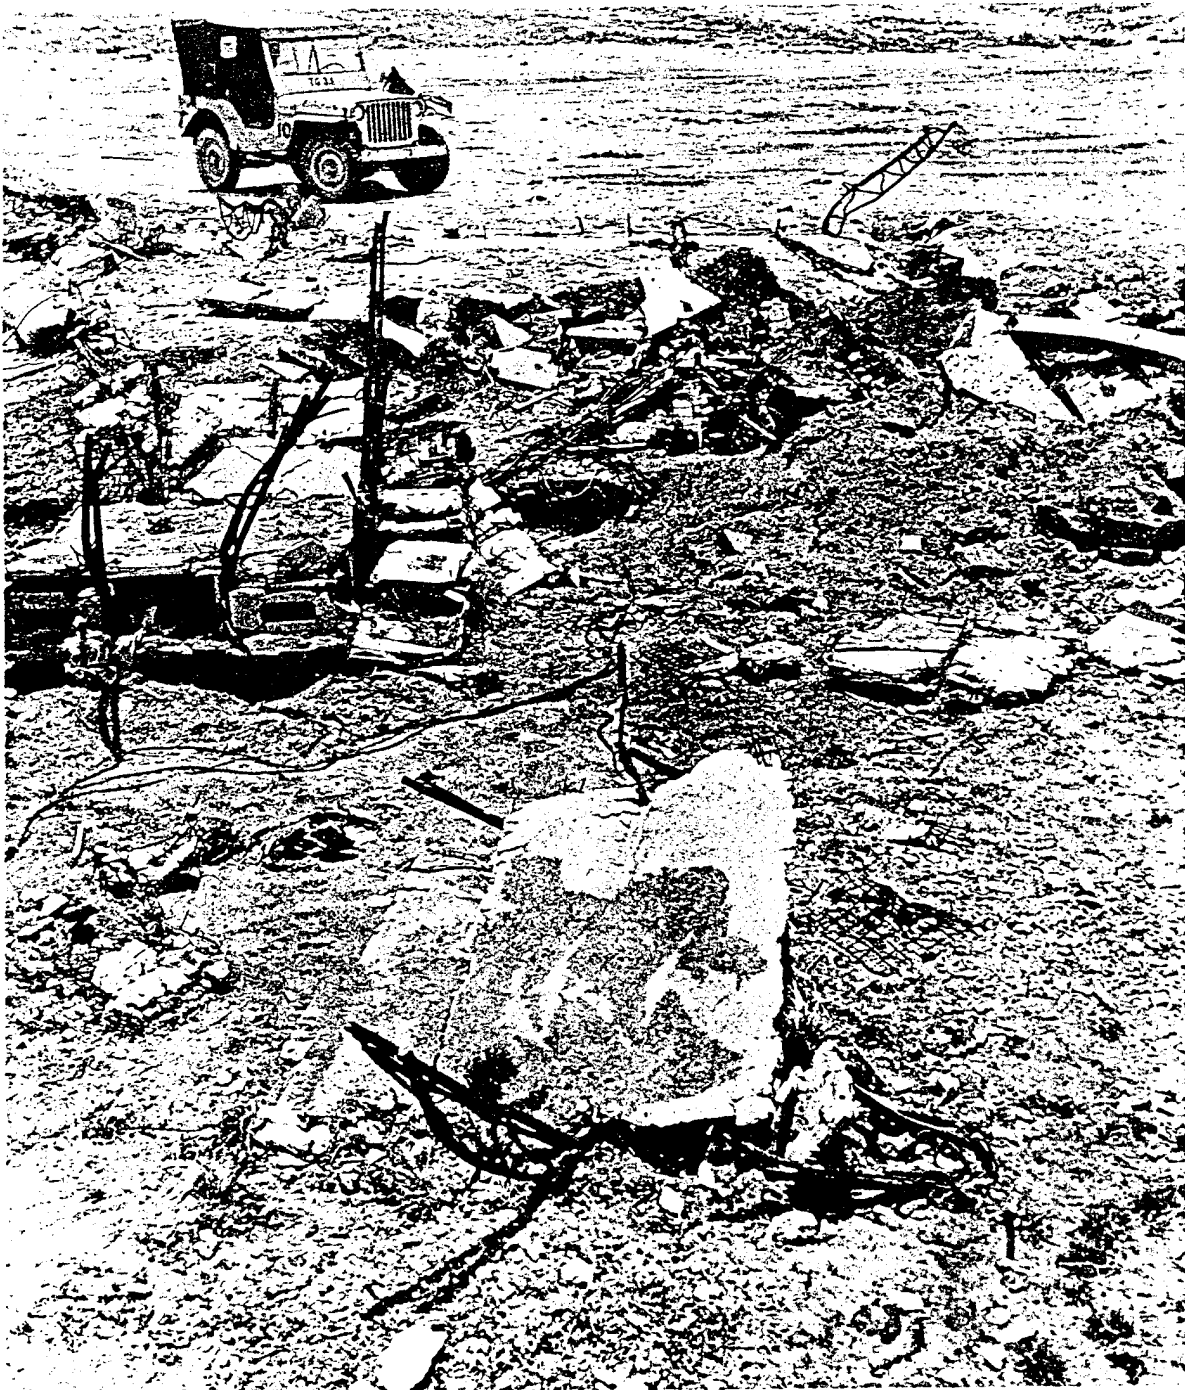
Fig. L.204 Remains of Front-wall Panel No. 24 (In Foreground) after Being Hurlled about 50 ft, Structure 3.2.3a.
Panel 25 is visible in left center of photograph.

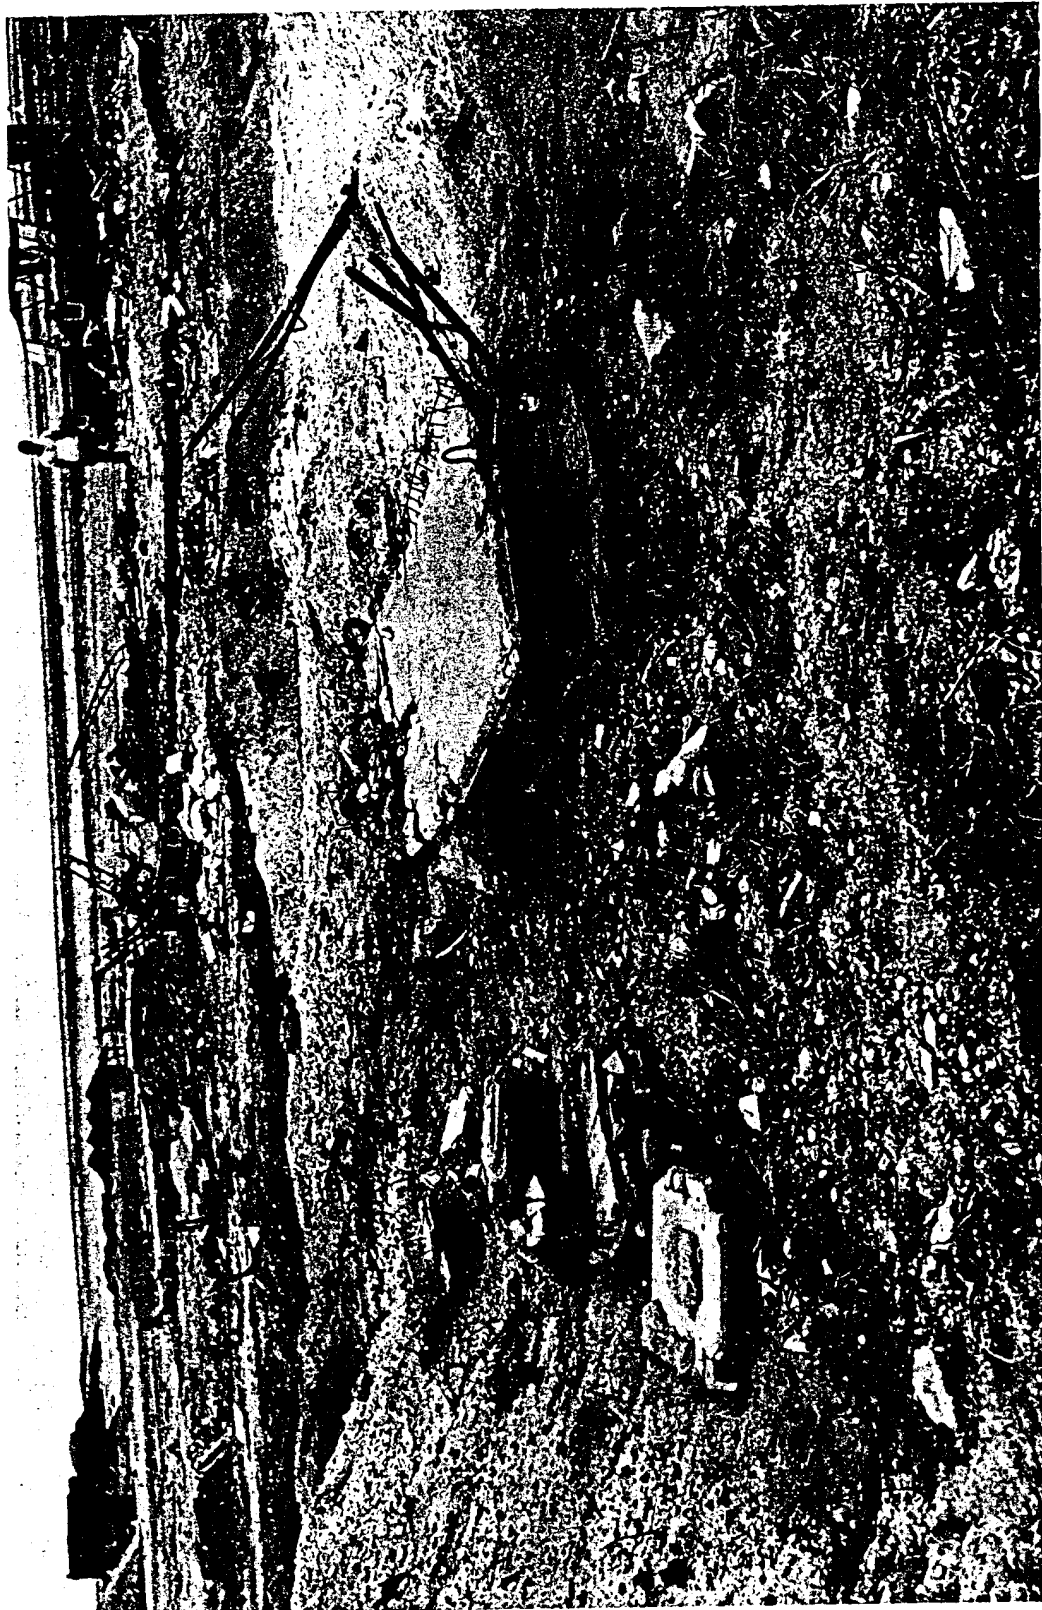
Fig. L.205 Remains of Front-wall Panel No. 28 after Being Hurled about 75 ft to the Rear, Structure 3.2.3a

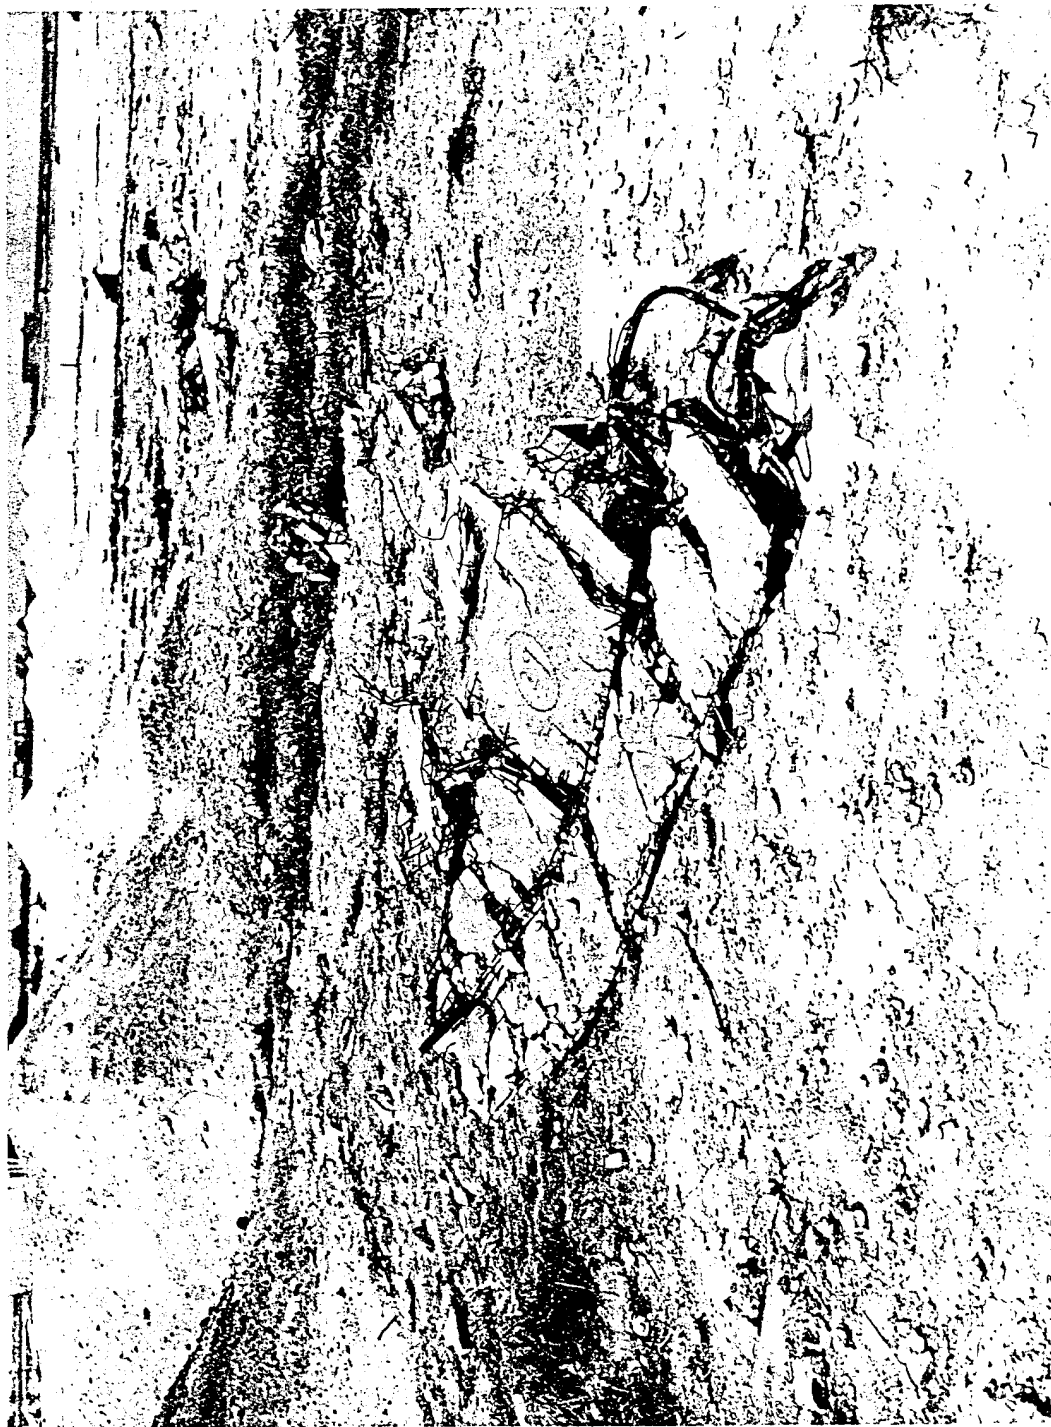
Fig. L.206 Remains of Front-wall Panel No. 29 after Being Hurled about 90 ft to the Rear, Structure 3.2.3a

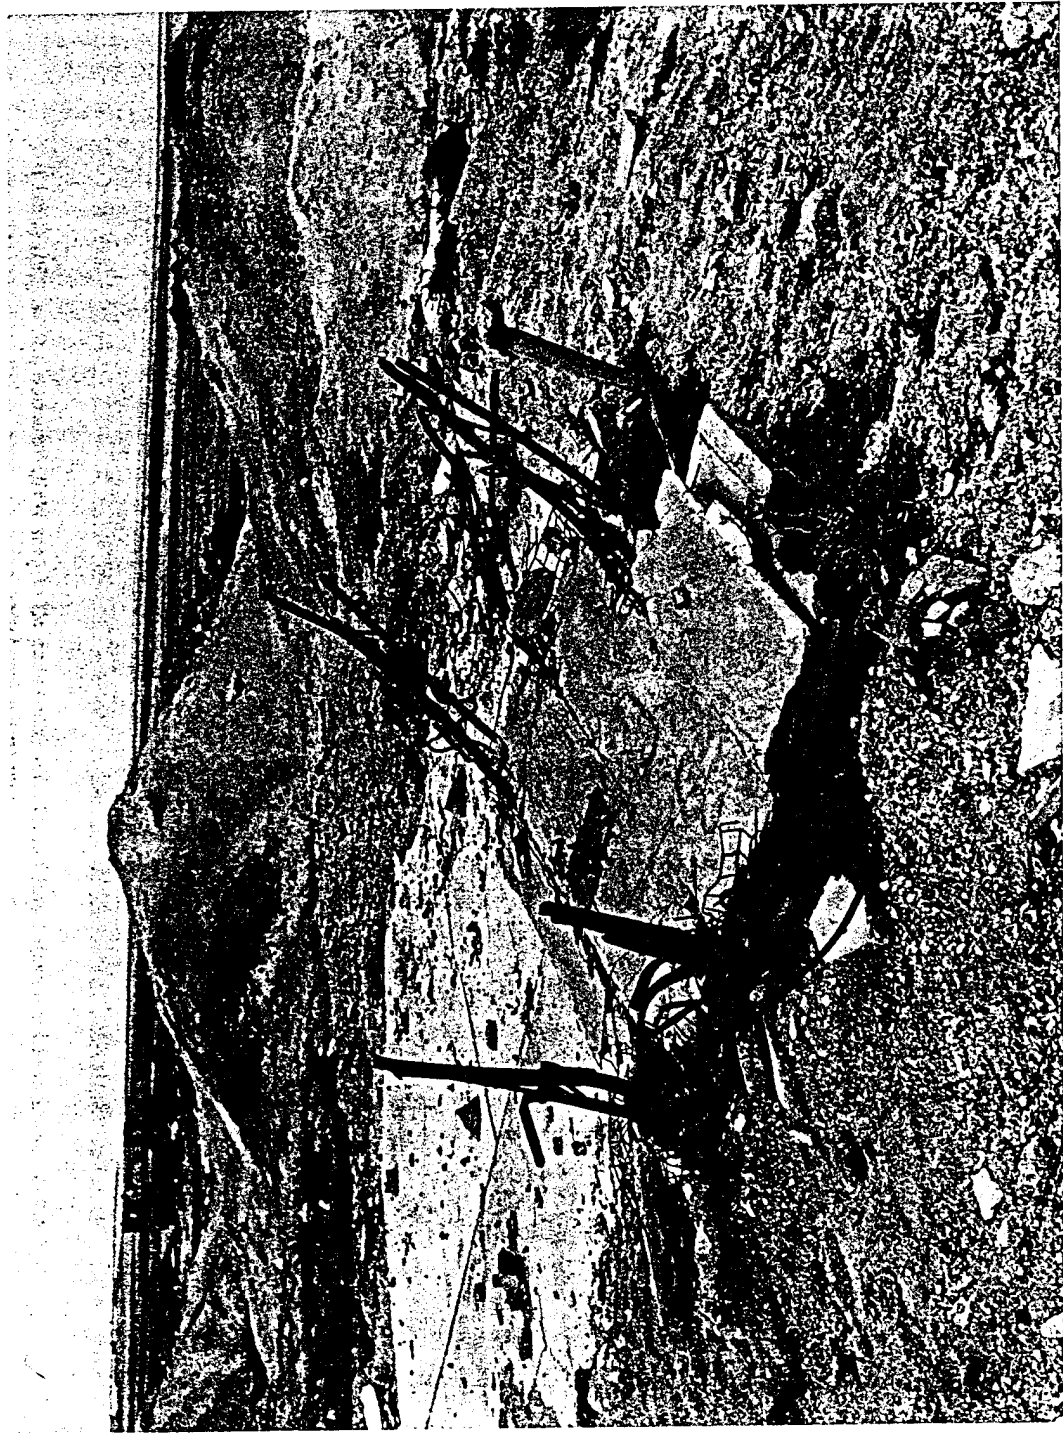
Fig. L.207 Remains of Front-wall Panel No. 27 after Being Hurled about 100 ft to the Rear, Structure 3.2.3a

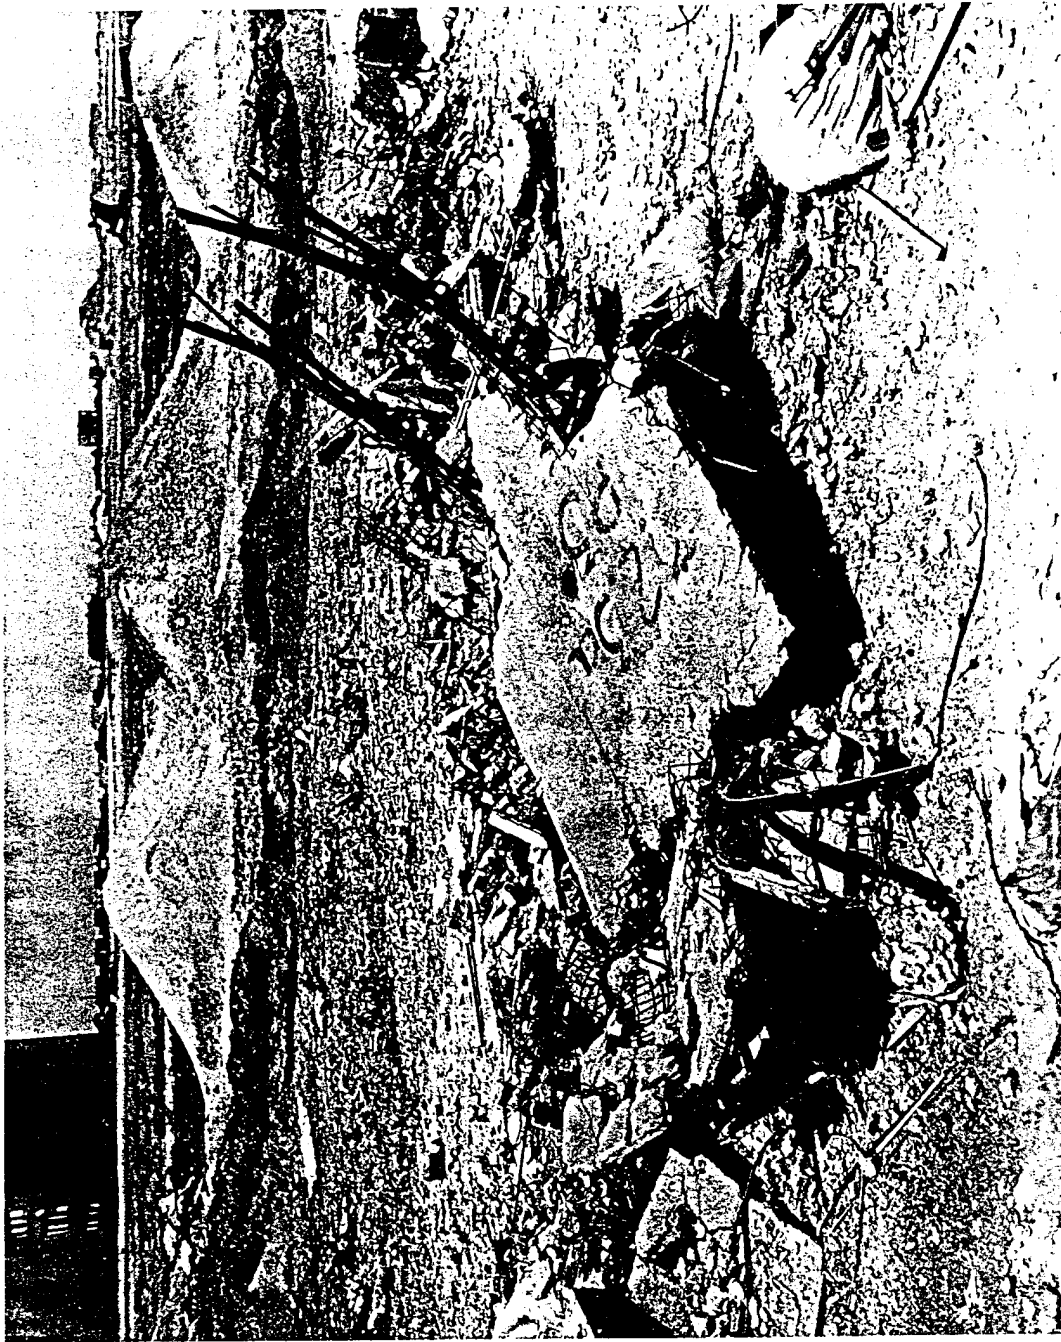
Fig. L.208 Remains of Front-wall Panel No. 26 after Rebounding off of Rear Wall, Structure 3.2.3a. This panel is lying on the foundation.

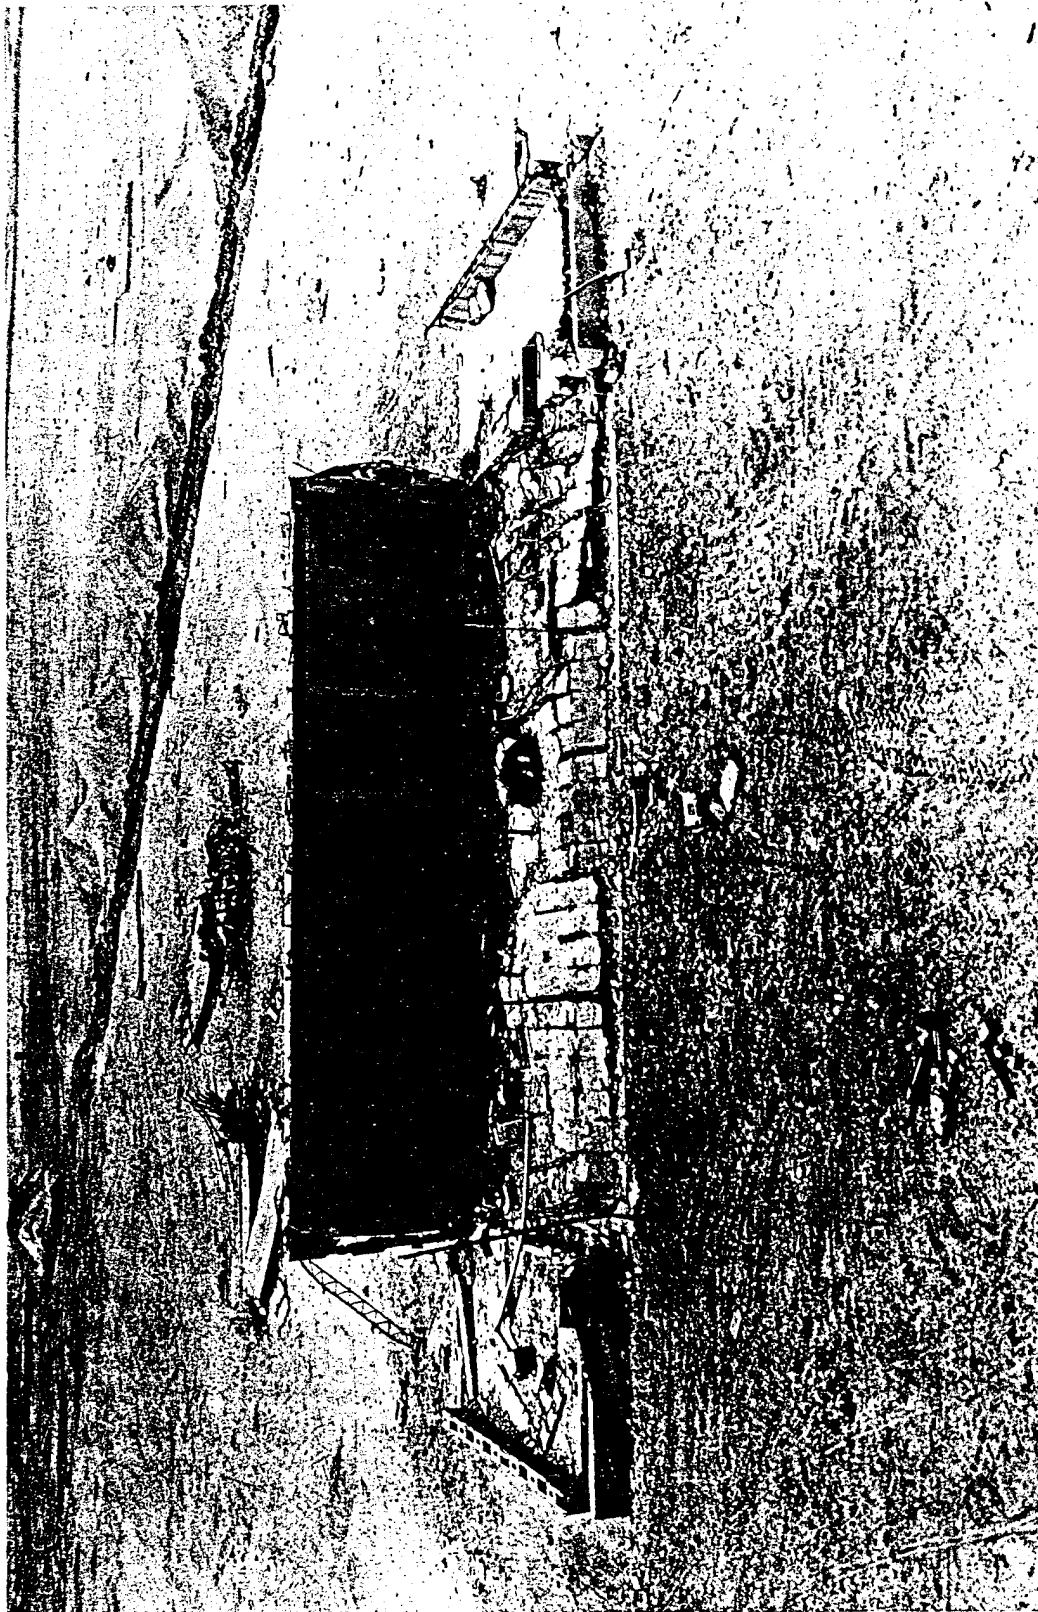
Fig. L.210 Aerial View of Structure Destroyed by Blast, Structure 3.2.3b. Inward collapse of front wall is clearly visible. Note no lateral displacement of end walls. Top rear wall is practically intact.
